GREEN ROOFS, GARAGES, DECKS & PORCHES

NEW GREEN ROOF GARDEN ON 3 CAR GARAGE BUCKTOWN NEIGHBORHOOD, CHICAGO, ILLINOIS

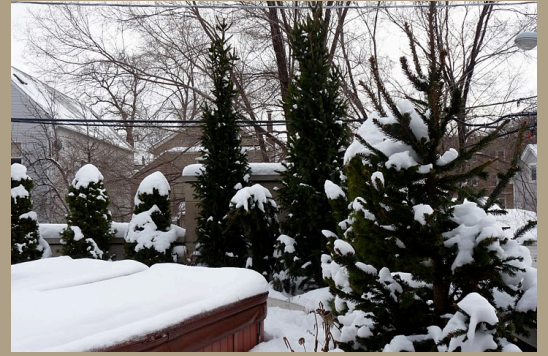
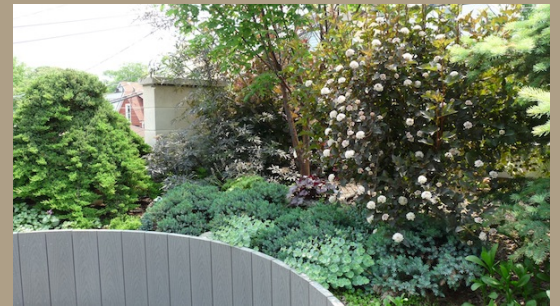
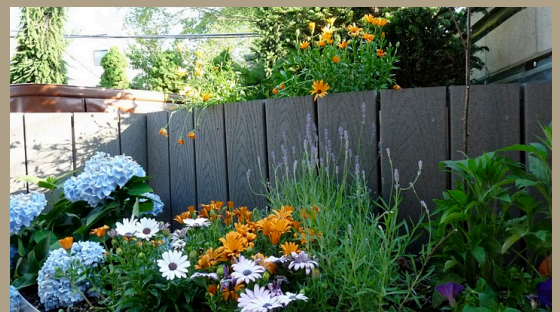
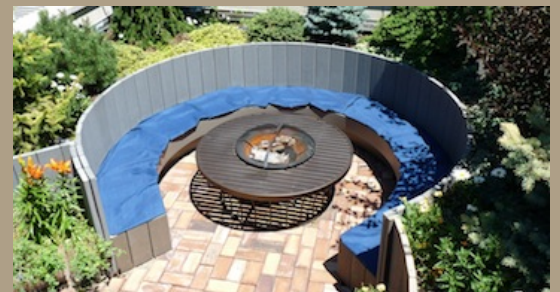
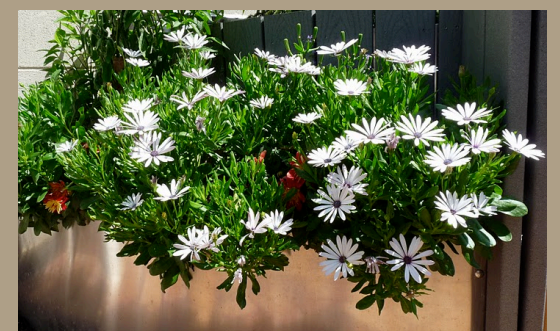
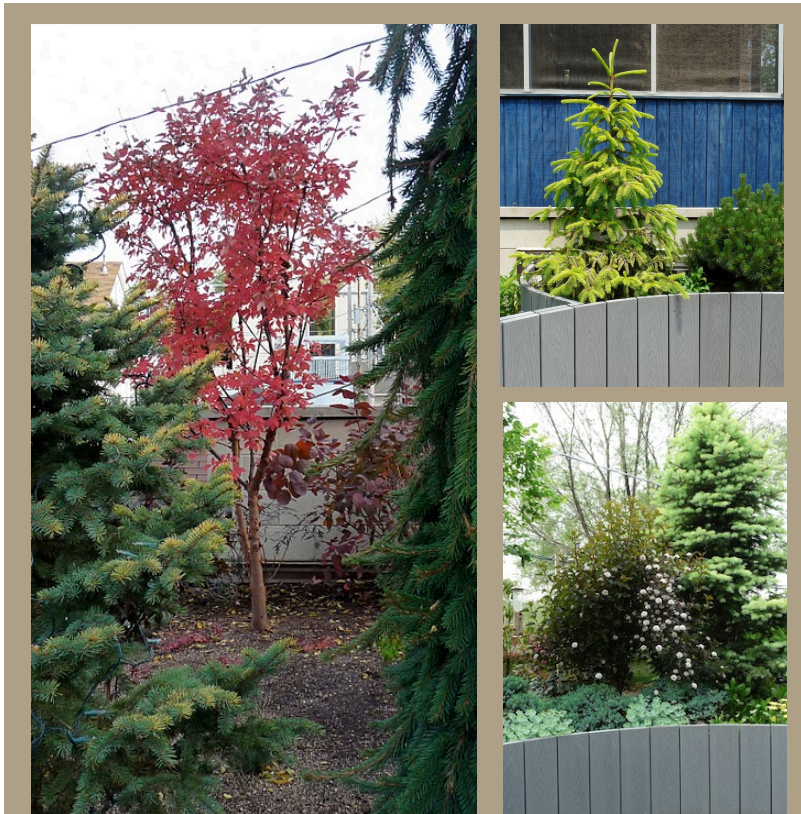
This "intensive" roof garden was built on top of a new 3 car garage. The roof structure was constructed of a concrete-steel composite to minimize height and interior columns.

Due to the short lot depth, the garage filled the backyard and the the roof was the only place for landscaping. An intensive garden allowed for a variety of trees and shrubs providing privacy, shade and a bird habitat with beautiful colors and textures. The patio on the rooftop has brick pavers salvaged from the building when the front facade was rebuilt.

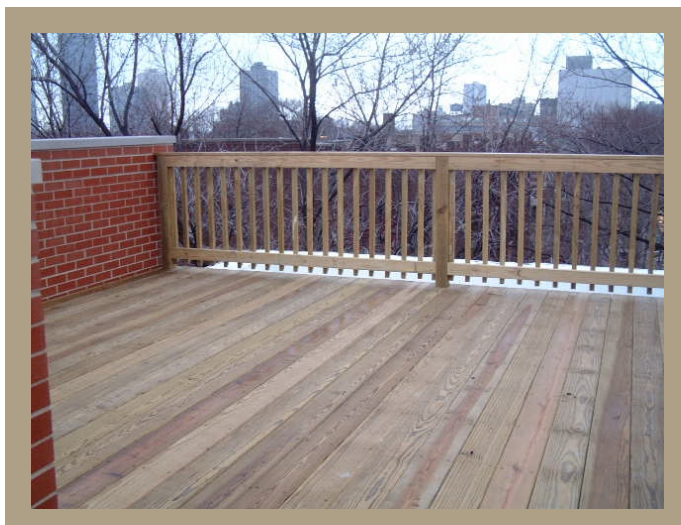
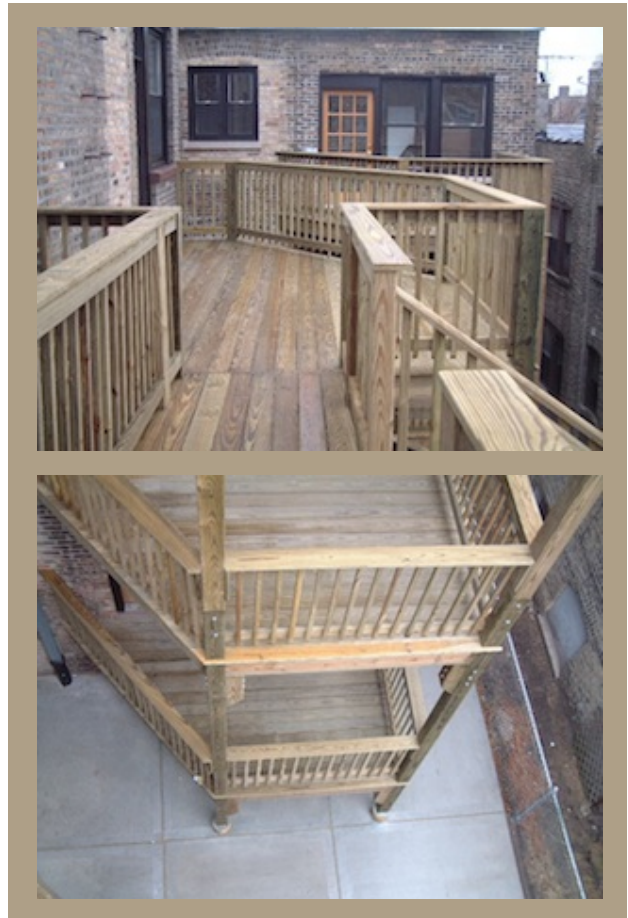
NEW ROOF DECK & PORCHES FOR 12 UNIT CONDOMINIUM BUILDING ANDERSONVILLE NEIGHBORHOOD, CHICAGO, ILLINOIS

All 12 porches and 2 stairways were replaced for this condominium conversion. The roof top deck was added to take advantage of the open views to the east and south. Each of the individual porch areas was designed to be a very functional size, while keeping within challenging building and zoning requirement dimensions and setbacks.

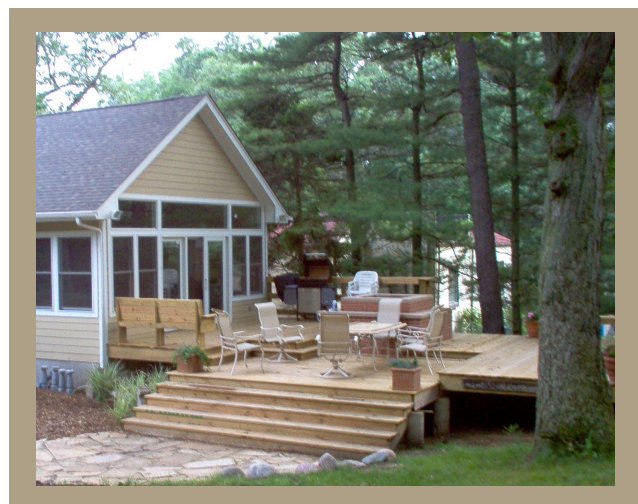
NEW DECK FOR SINGLE FAMILY HOME BEVERLY SHORES, INDIANA

This large deck has a central masonry fire pit, multiple levels to create more intimate seating/gathering areas and work with the rising topography of the lot. The wide stair allows easy flow of movement from the yard to the deck. Benches and a grill around the perimeter are used in place of railings for a more open feeling.

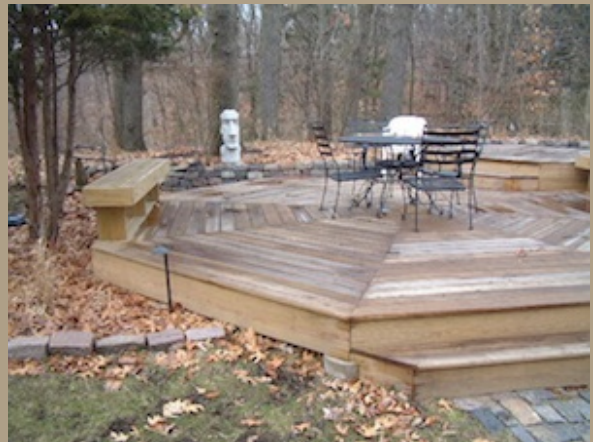
NEW DECK FOR SINGLE FAMILY HOME BEVERLY SHORES, INDIANA

This octagon shaped deck has two smaller octagon shaped decks attached to it. One is used for a cooking area and the other will be used as a future gazebo.

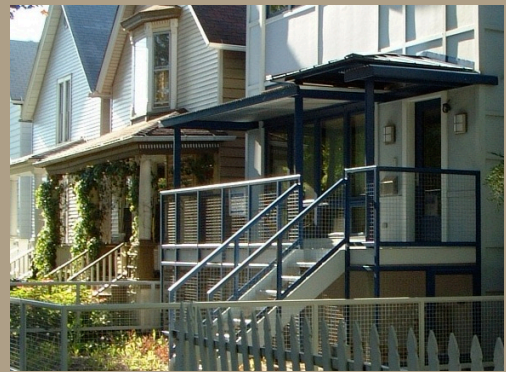
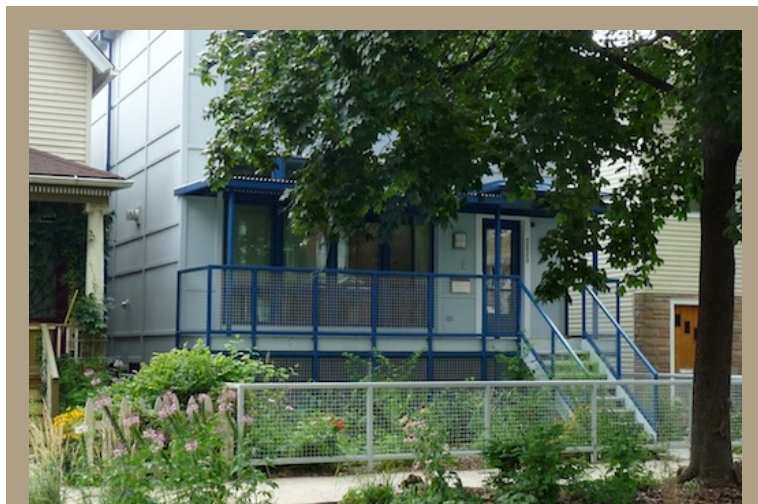
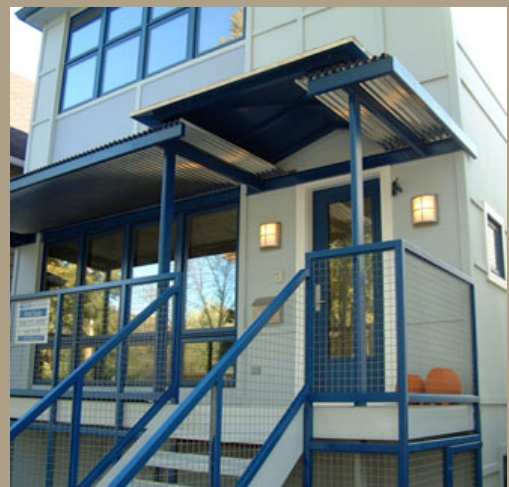
FRONT PORCH FOR SINGLE FAMILY HOME BUCKTOWN NEIGHBORHOOD CHICAGO, ILLINOIS

Front porches are a common feature on the street. The covered porch on this new home provides context to the neighboring homes with contemporary flair.

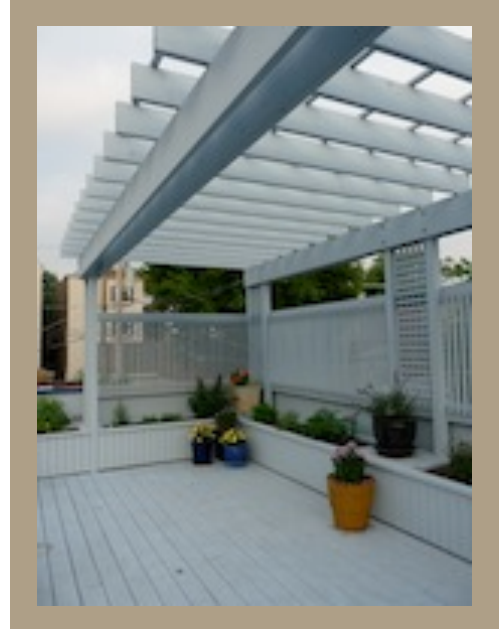
GARAGE ROOF DECK FOR SINGLE FAMILY HOME
BUCKTOWN NEIGHBORHOOD
CHICAGO, ILLINOIS

This stained cedar rooftop deck has built-in planters, privacy screening and a trellis to provide shade. The light color stain also helps to keep the deck cool.

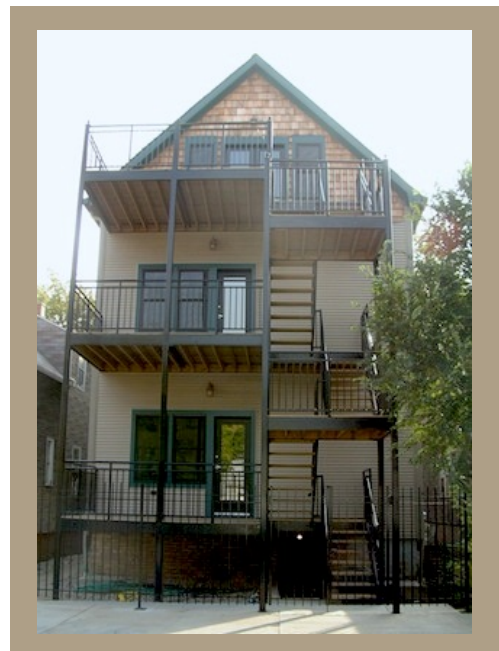
REAR PORCH ON 2 UNIT RESIDENCE
BUCKTOWN NEIGHBORHOOD
CHICAGO, ILLINOIS

The owner wanted to allow for a future wood frame garage to be constructed behind this new porch. Due to the shallow lot, the garage would have to be built very close to the porch. If the porch were built with wood framing, the building code would not allow the garage to be built. Therefore, the porch was constructed with steel framing and painted green to blend with the wood trim on the building.
